Technical Data		
Sensing range	2.5 - 10 m	
Supply voltage	11 - 36 V dc	
Voltage ripple	15% (within supply range)	
Reverse polarity protected	Yes	
Short circuit protection	Yes	
Inductive load protection	Yes	
Power consumption	Transmitter (one): max. 100 mA.	Receiver (one): 50 mA
Maximum output load	200 mA, 36 V dc	
Light immunity	> 100.000 lux @ 5°	
Temperature, operation	-20 to + 65 ° C.

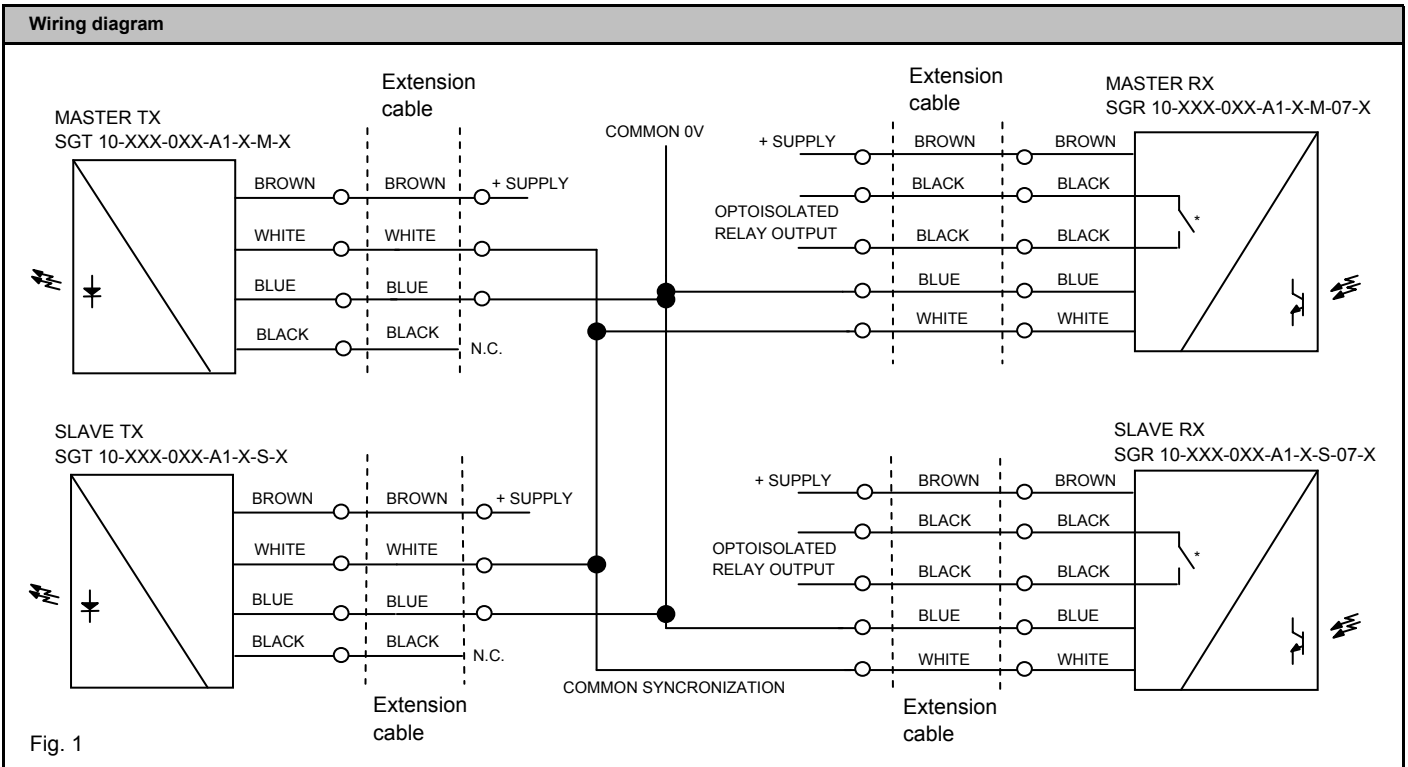
Output					
Model	Output type	Output mode	Object	Output switch	Yellow LED
SGR 10-XXX-0XX-A1-X-M-07-X	OPTO RELAY	Light operated (NC)	Absent	Closed	On
		Light operated (NC)	Present	Open	Off
SGR 10-XXX-0XX-A1-X-S-07-X	OPTO RELAY	Light operated (NC)	Absent	Closed	On
		Light operated (NC)	Present	Open	Off

* Relay type: Normally Open
